EAST STAFFORDSHIRE BOROUGH COUNCIL

A report on a Tier 2 hydrological risk assessment of the viability of extending Stapenhill Cemetery.

24th May 2021

TGMS1163.3

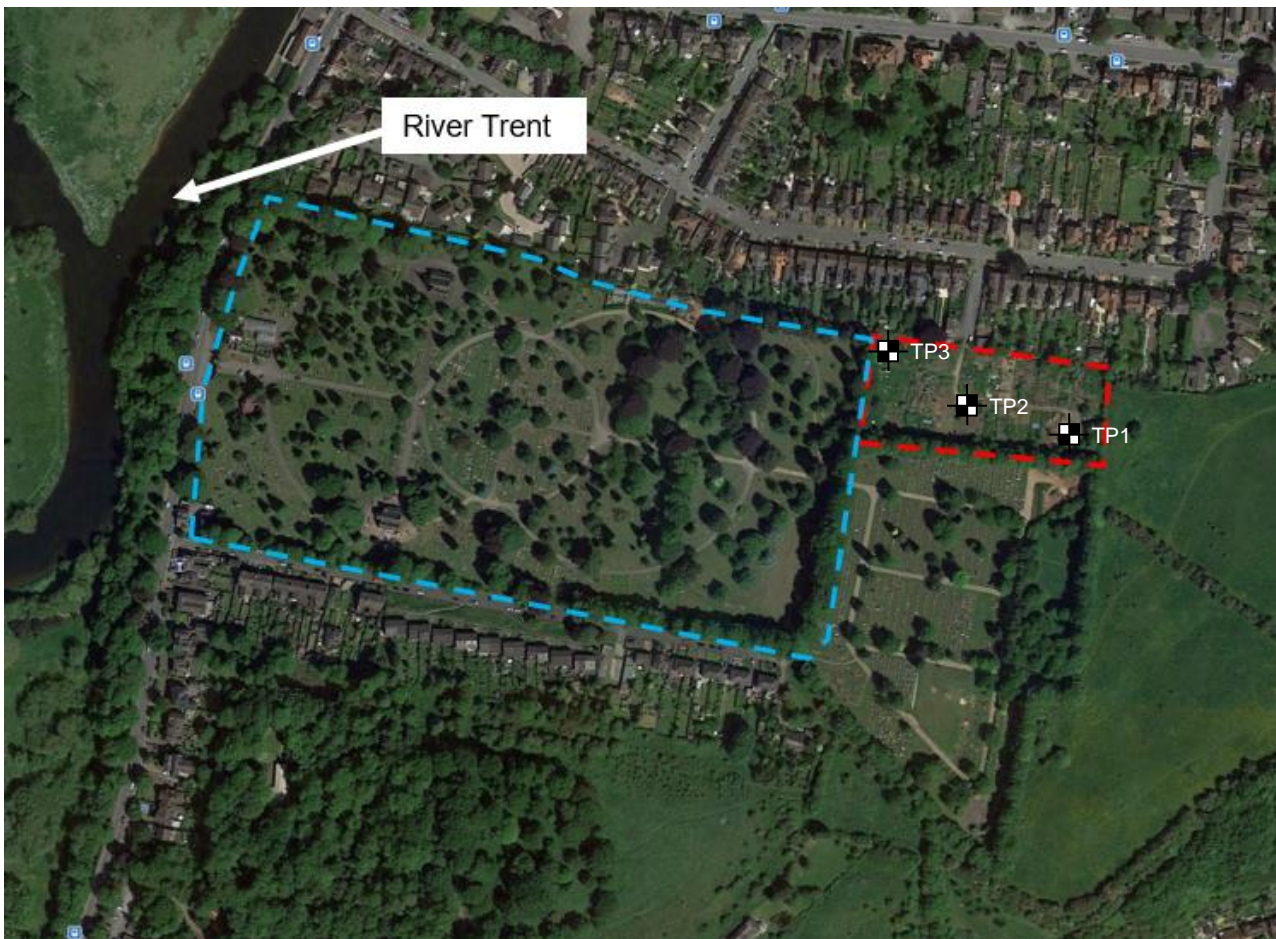
The site comprises a rectangular plot of allotments which is located immediately adjacent to the north-eastern corner of the existing cemetery and is outlined in red on the aerial view below. The site can be accessed via a track at the end of Claverhouse Road off Scalpcliffe Road (Figure 1).

Figure 1. Site location (within red-dashed line – courtesy of Google Earth Pro). The existing cemetery is outlined in blue. TP1 to TP3 mark the approximate locations of the test pits

In order to explore the underlying soil type and structure further, three profile pits were excavated at the locations indicated on Figure 1. A summary of the soil characteristics prevailing in each of these pits is presented in the following section.

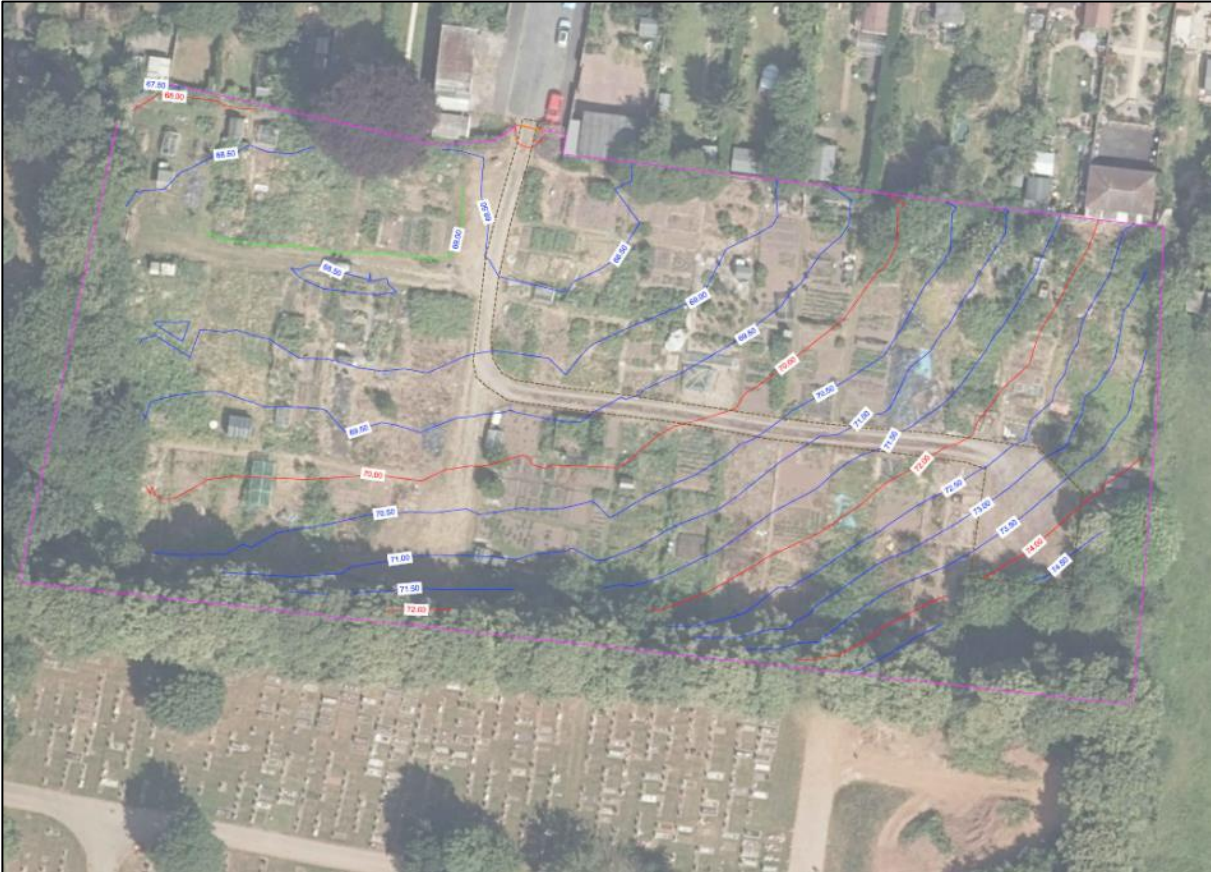
TGMS has previously conducted a levels survey of the development area (Figure 8). The site has a ground elevation of between 67.5 and 74.5 m above ordnance datum (AOD) with the ground surface sloping towards the north-west. This fall of 7 m over 158 m equates to a mean gradient of 4.4%

Figure 8. Levels survey results (0.50 m contours).

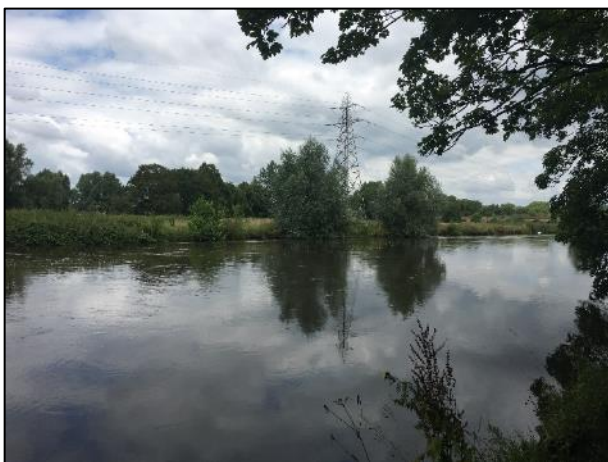
Figure 9. The River Trent.

The River Trent is located approximately 500 m north-west of the site (Figures 9 and 10), but no watercourses abut or cross the site.

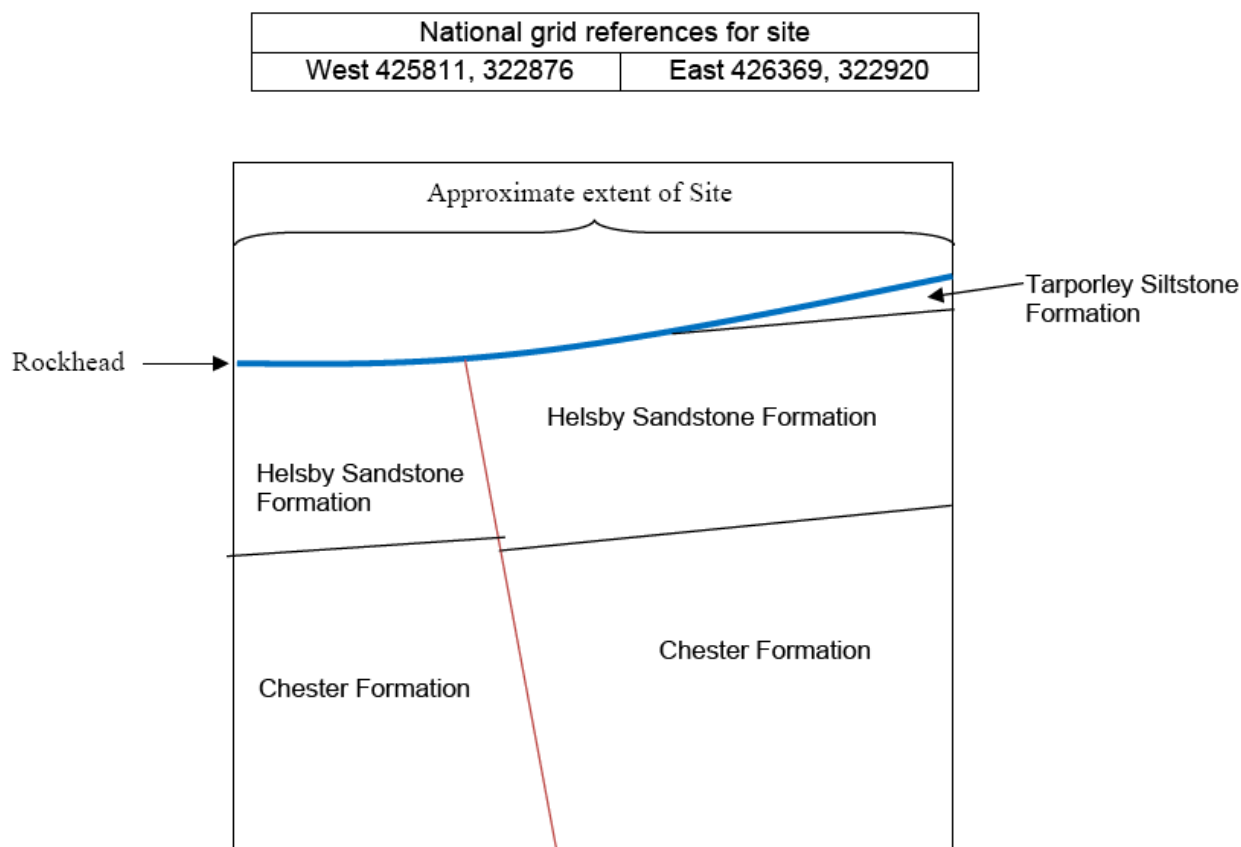
This sketch represents an interpretation of the geometrical relationships of the main rock units described in the text. It is not to scale.

The blue line indicates 'rockhead'; that is the base of superficial deposits. This is the 'geological rockhead', as distinct from the 'engineering rockhead', which is the base of 'engineering soil' (in the sense of BS5930:1999).

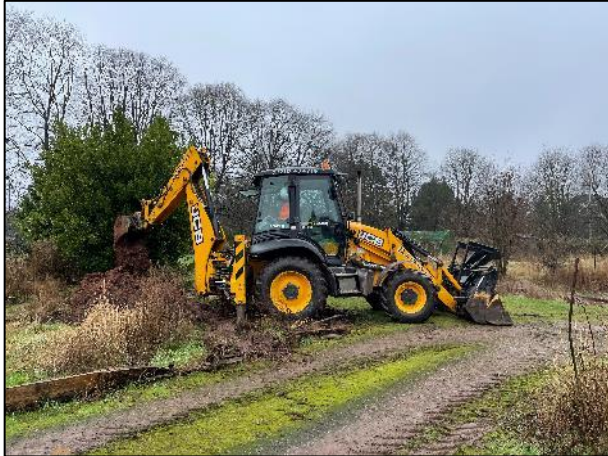
Figure 24. Digger used to excavate soil profile pits.

In order to facilitate the excavation of pits down to at least 1 m below maximum anticipated burial depth, a JCB 3CXeco excavator was used for the assessment (Figure 24).

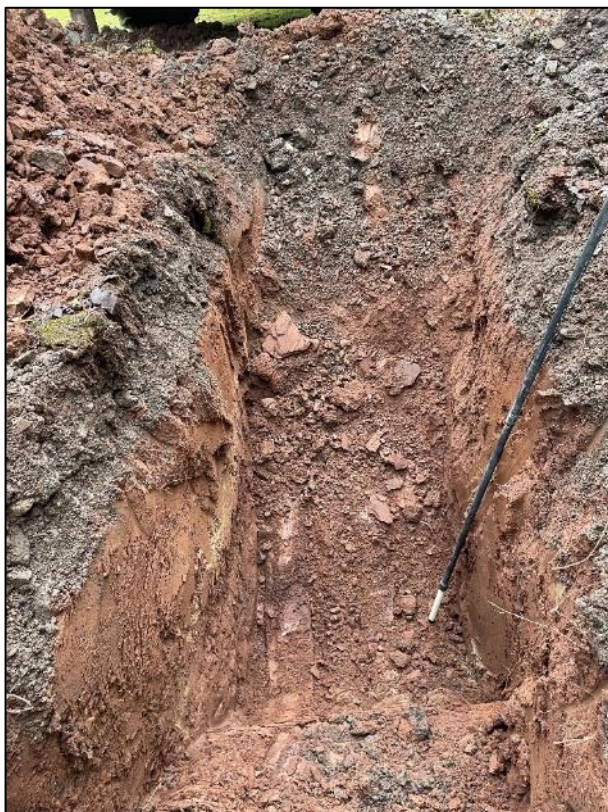
TP1 was located in an area of high elevation (74.50 m Above Ordnance Datum (AOD)) on an area previously used for car parking in the south-eastern corner of the site (Figure 1). The excavation at TP1 revealed a profile that comprised 0.30 m of DOT Type 1 stone sub-base over red SANDY SILT LOAM subsoil (mudstone) to 1.50 m over hard red SANDSTONE which extended beyond the maximum sampling depth of 2.00 m (Figure 25). No Groundwater was encountered in the test pit.

Figure 25. DOT Type 1 stone over SANDY SILT LOAM subsoil – TP1

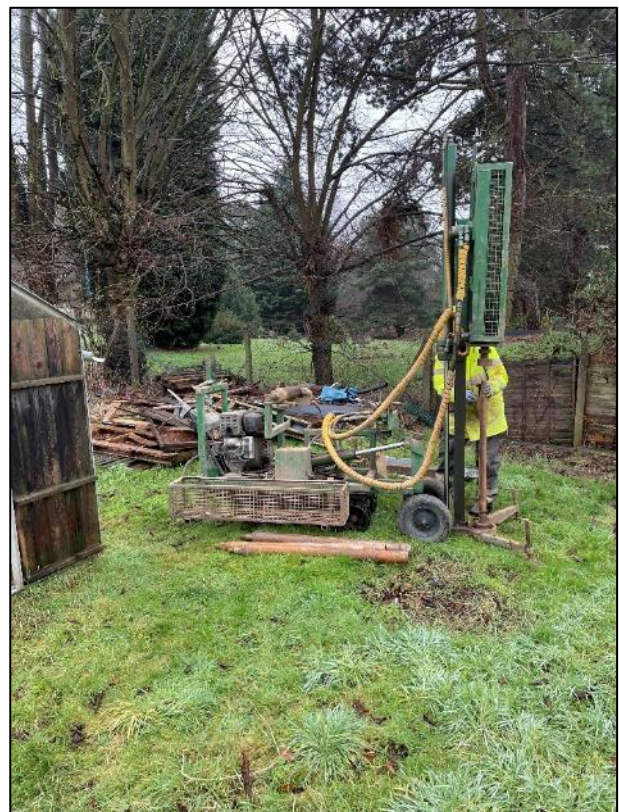
Figure 26. Competitor Dart 130 percussion rig

The composition of the underlying geology was also assessed through window sampling using a Competitor Dart 130 percussion rig (Figure 26), however this was aborted at 1.60 m below ground level (bgl) due to the hard sandstone.

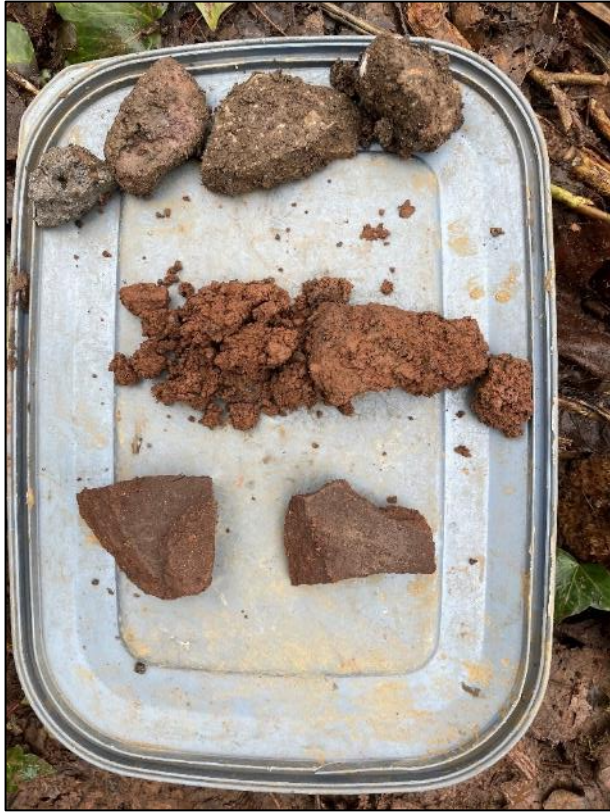
Samples extracted from 0.10 m, 1.00 m and 2.00 m are presented in Figure 27 and window sampling cores are presented in Figure 28.

Figure 27. Soil samples from 0.1 m to 2.0 m – TP1.

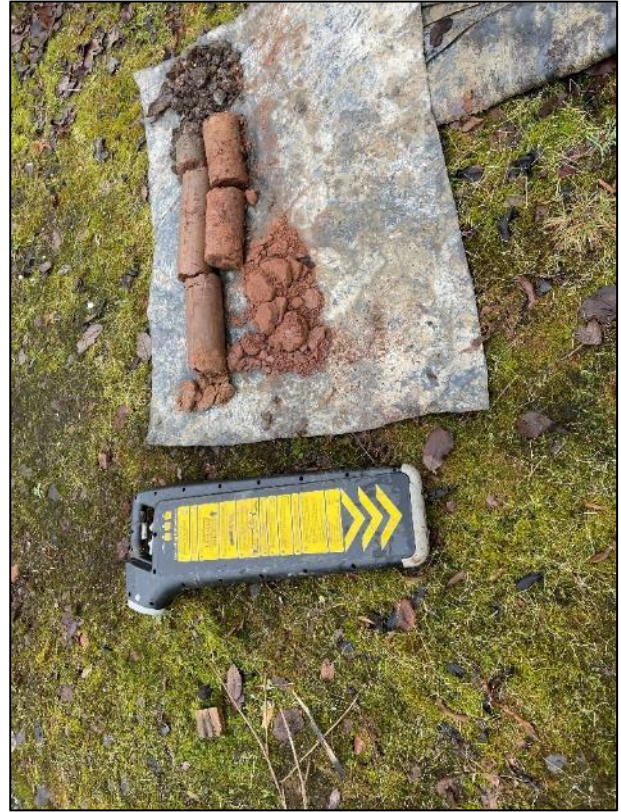
Figure 28. Window sampling cores from TP1.

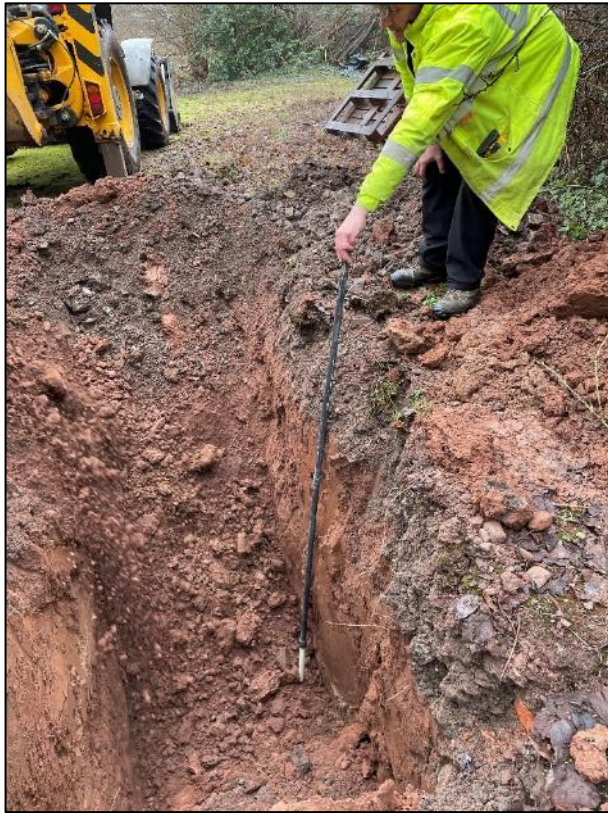
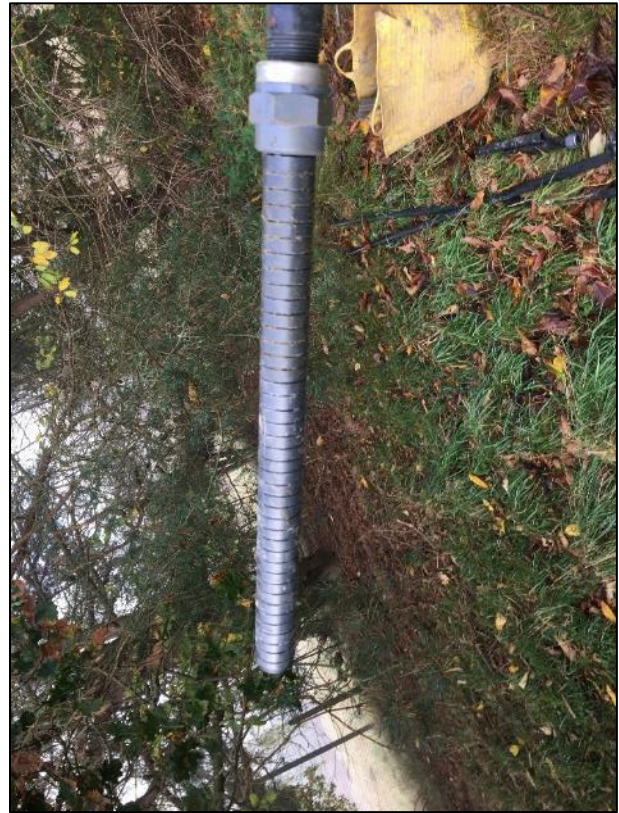
In order to facilitate ongoing monitoring of the groundwater, a dipwell comprising a piezometer tip and solid pipe was installed and back-filled in the TP1 to a depth of 2.00 m (Figures 29 and 30).

Figure 29. Installation of a dipwell – TP1.

Figure 30. Piezometer for dipwell installation.

Borehole logs are appended. The dipwell will be monitored over the spring period to establish the presence of any perched groundwater, and whether it rises to less than 1 m below maximum anticipated burial depth.

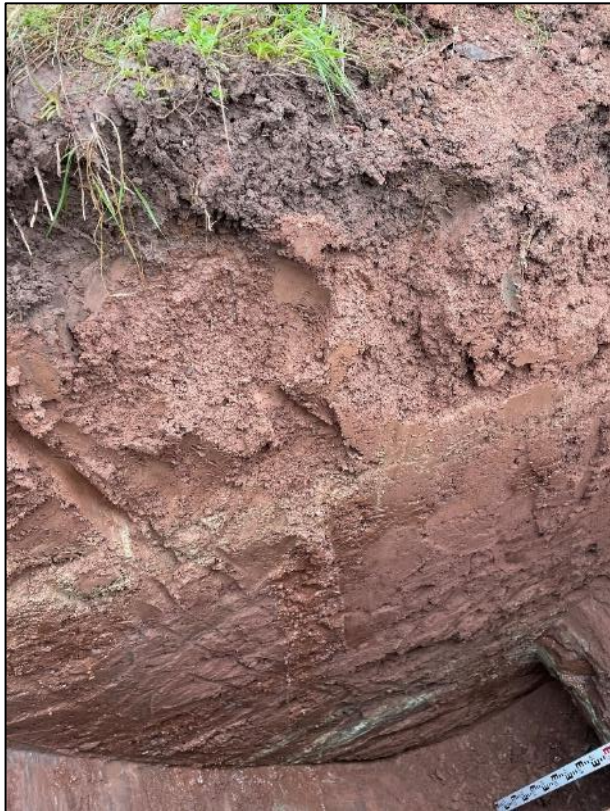
TP2 was located in an area of mid elevation (69.50 m AOD) towards the centre of the site (Figure 1). The excavation at TP2 revealed a profile that comprised 0.25 m of brown CLAY LOAM topsoil over red CLAY LOAM subsoil (mudstone) to 1.70 m (Figure 31) over red SANDSTONE to 2.10 m over grey SANDSTONE to 2.40 m over hard red SANDSTONE which extended beyond the maximum sampling depth of 2.90 m (Figure 32). No Groundwater was encountered in the test pit.

Figure 31. CLAY LOAM topsoil over red CLAY LOAM subsoil (mudstone) – TP2.

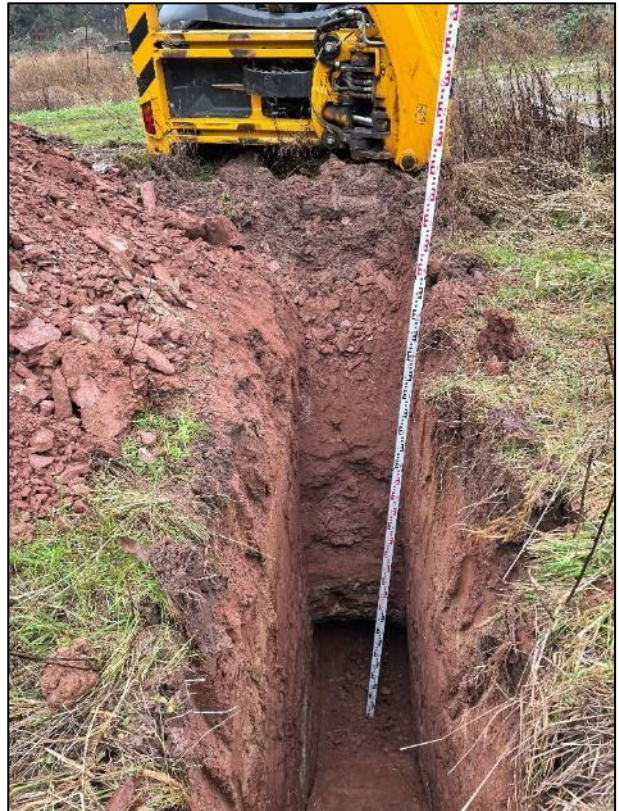
Figure 32. Red SANDSTONE to 2.10 m over grey SANDSTONE to 2.40 m over hard red SANDSTONE – TP2.

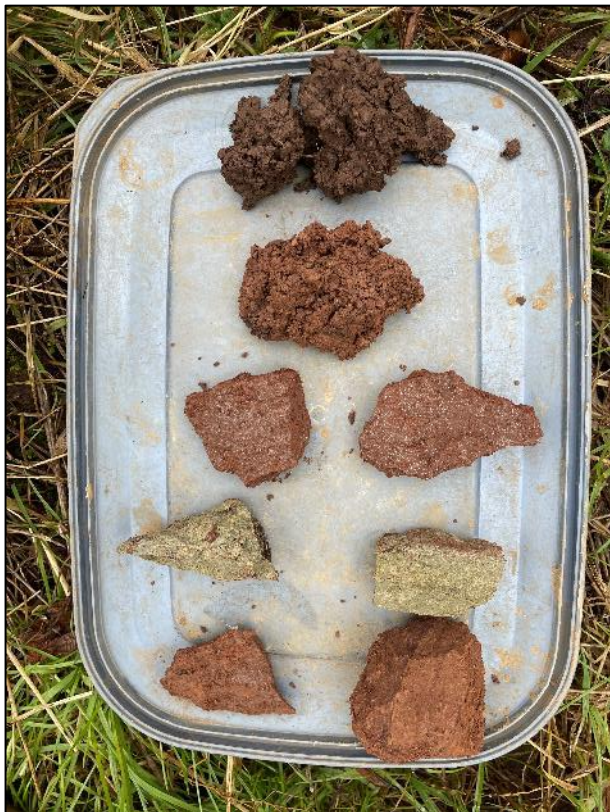
Figure 33. Soil samples from 0.1 m to 2.9 m – TP2.

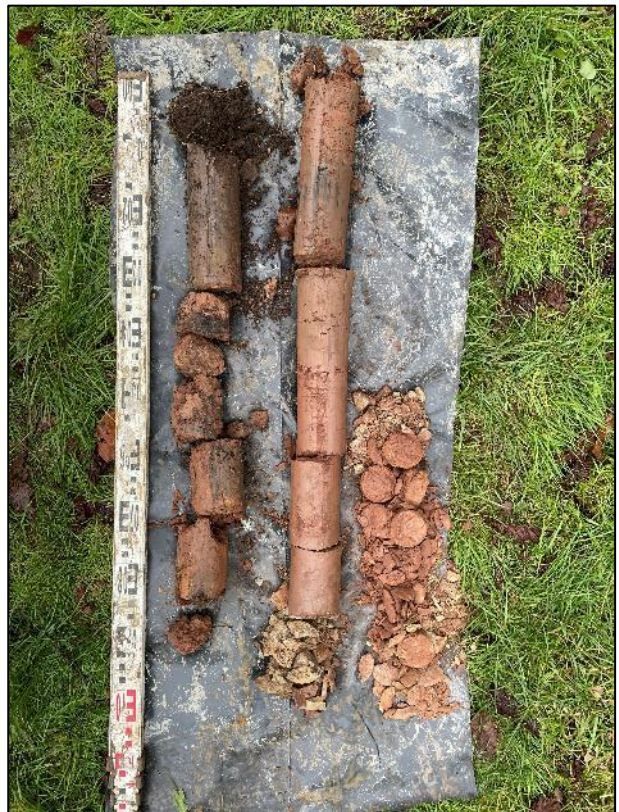
Figure 34. Window sampling cores from TP2.

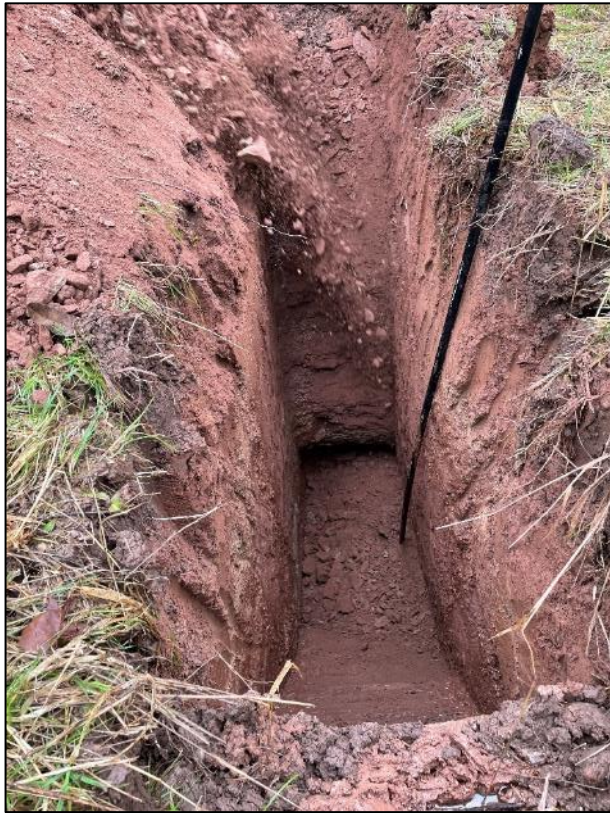
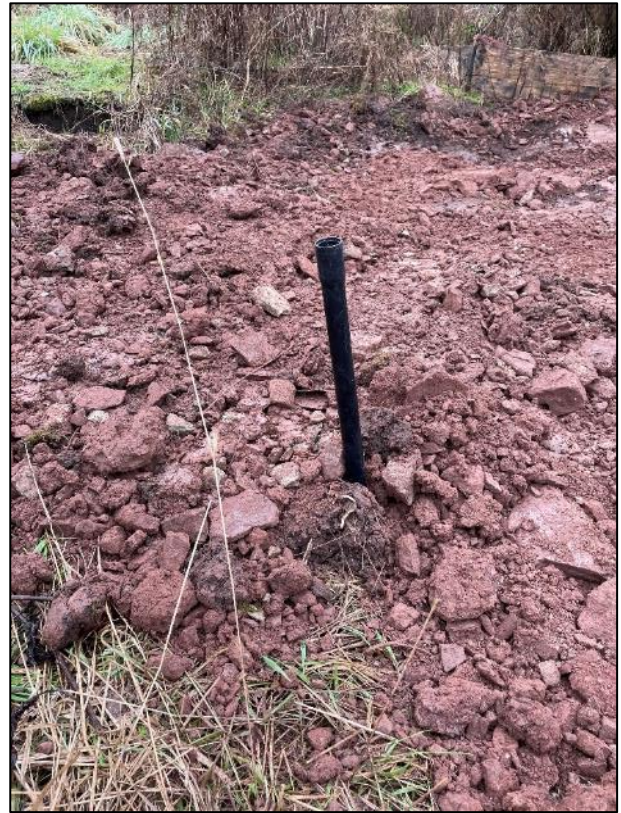
In order to facilitate ongoing monitoring of the groundwater, a dipwell comprising a piezometer tip and solid pipe was installed and back-filled in TP2 to a depth of 2.90 m (Figures 35 and 36). The dipwell will be monitored over the spring period to establish whether ground water rises to less than 1 m below maximum burial depth.

Figure 35. Dipwell installed TP2.

Figure 36. Dipwell installed TP2.

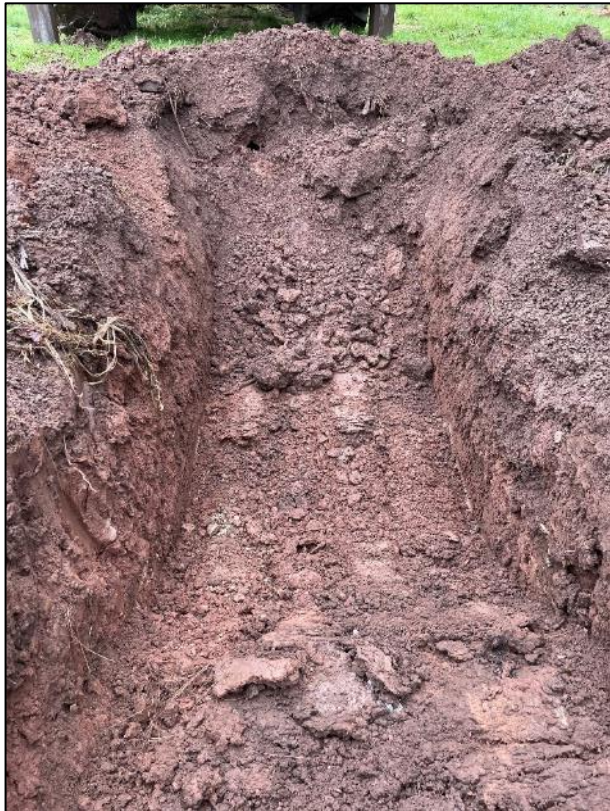
TP3 was excavated in an area of low elevation (68.00 m AOD) towards the north-western corner of the site (Figure 1). The excavation at TP3 revealed a profile that comprised 0.25 m of brown CLAY LOAM topsoil over red CLAY LOAM subsoil (mudstone) to 1.80 m (Figure 37) over grey SANDSTONE to 2.00 m over hard red SANDSTONE which extended beyond the maximum sampling depth of 2.20 m (Figure 38). No Groundwater was encountered in the test pit.

Figure 37. 0.25 m of brown CLAY LOAM topsoil over red CLAY LOAM subsoil (mudstone) to 1.80 m – TP3.

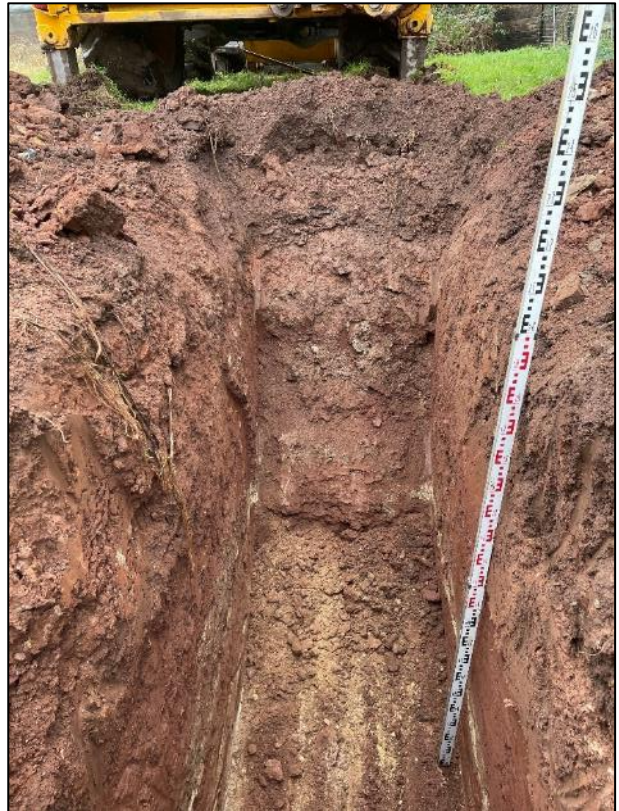
Figure 38. Grey SANDSTONE to 2.00 m over hard red SANDSTONE – TP3.

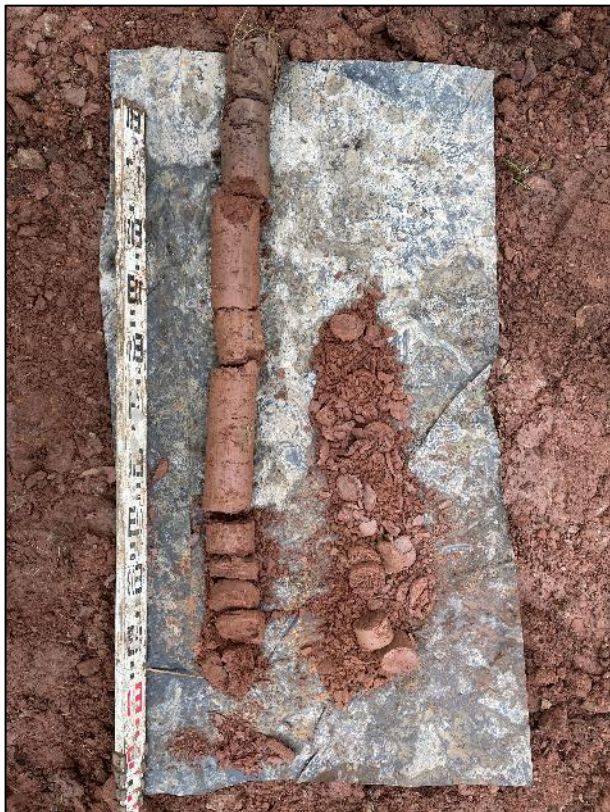
Figure 39. Window sampling cores from TP3.

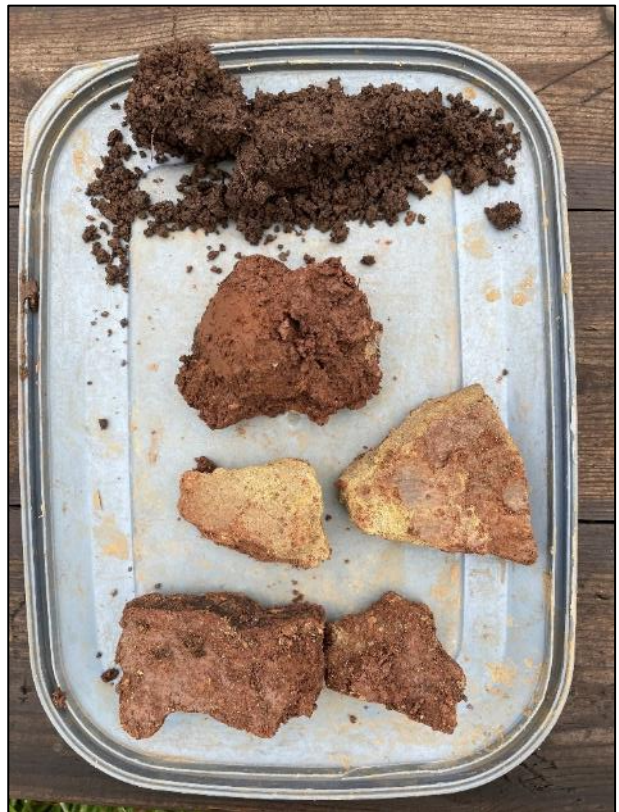
Figure 40. Soil samples from 0.1 m to 2.2 m – TP3.

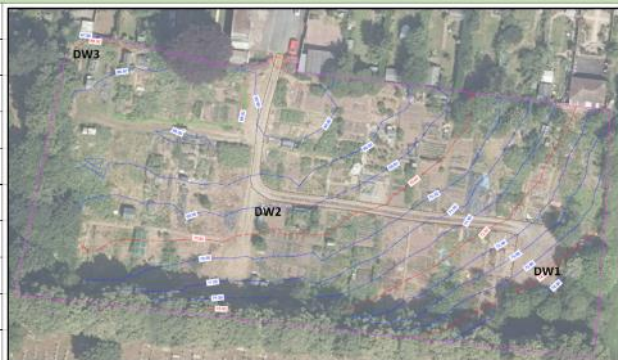
With reference to Table 4, groundwater has only been encountered in Dipwell 2 which is located towards the centre of the site at mid-elevation. It is concluded that water is perching above the excavated surface of the Helsby Sandstone Formation.

Dipwell 2 was backfilled in Test Pit 2 (as the window sampling rig refused at 2 m). The shallowest measurement to-date is 1.65 m bgl which was observed on the 17th March 2021 during a period of very wet weather.

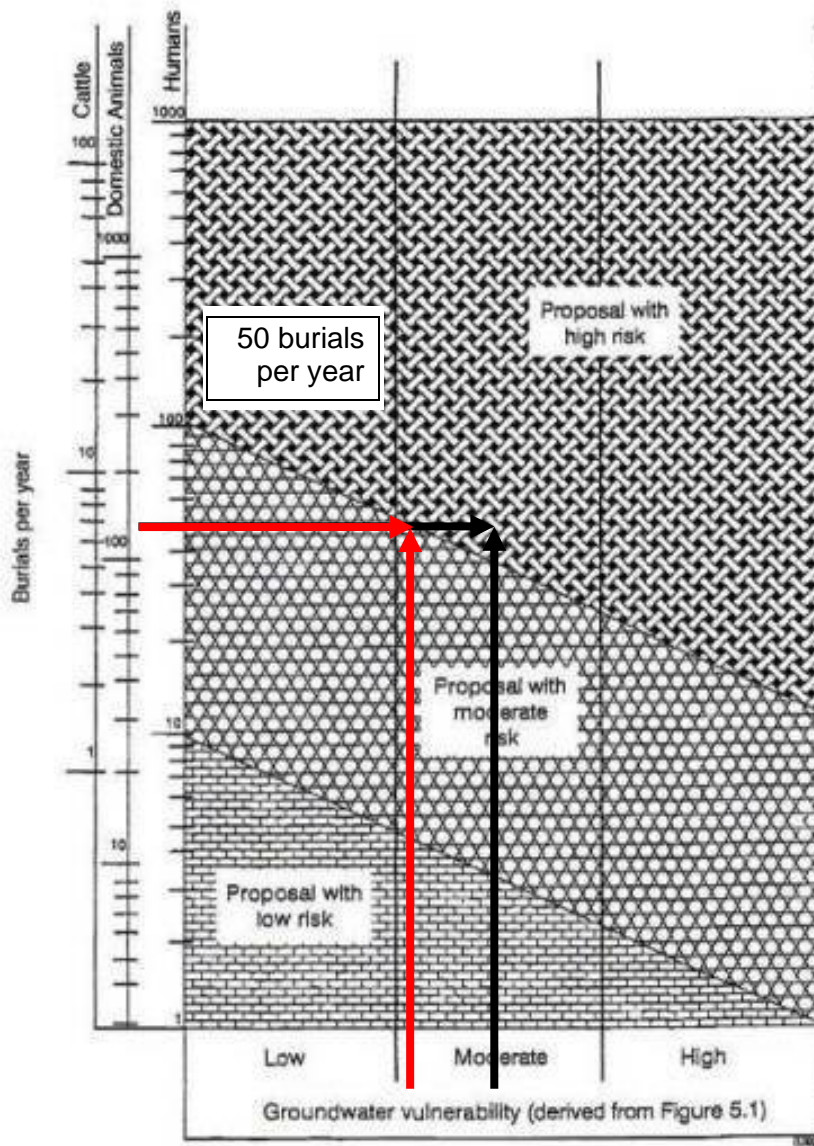
The EA determine the appropriate level of risk assessment required by considering a combination of the scale of development (i.e. number of burials) and the vulnerability class of the site using a nomograph reproduced in Figure 41.

Figure 41. Schematic relationship between burial rates, vulnerability class and level of risk (from EA R & D Technical Report P223 (1999)).

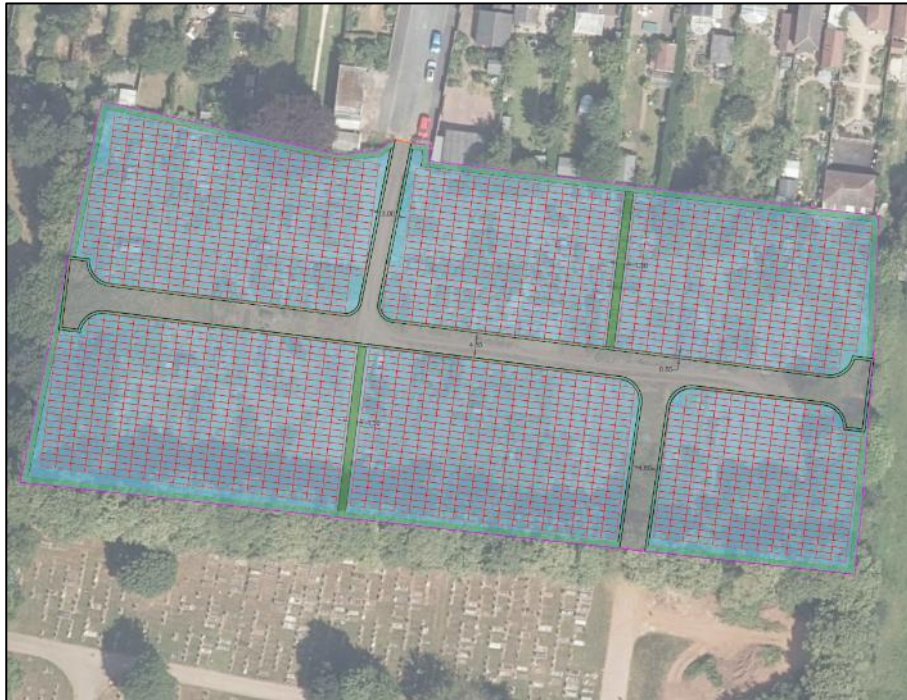
TGMS has previously produced a conceptual layout for the proposed cemetery extension (Drawing Tgms1163.1-2) which is part reproduced in Figure 42.

Figure 42. Conceptual design for the layout of the proposed cemetery extension. (Extract from drawing Tgms1163.1-2).

A standard adult grave space size in a cemetery usually measures 2.74 m x 1.22 m (9ft x 4ft). This space permits graves to be excavated to receive typical coffins measuring 1.96 m x 0.6 m (6ft 5in x 2ft) and still leave sufficient virgin ground between each excavated grave.
